GÁG ehf Verk- og tækniráðgjöf Glaði Ágúst Guðmundsson - Byggingatæknir, kt: 250860-7499 Glaðsátt 41, 221 Hafnarfj., s: 866 0880 Netfang: glaðguðmunds@gmail.com.	MKV. 1:50 á A1	DAGS. 10.07.2018	ÚTGÁFA NR. 1
HEITI VERKS: Sumarhús Heiðarbæ - Land 223275	TEIKN. GG	REIKN. GG	VERKNR. 5371-18 NR. TEIKNINGAR B-103-3d
HEITI TEIKNINGAR 3D - Skýringarmynd	ÁRTUN HÖNNUÐAR Erla Þ. Gunnarsdóttir	ÁRTUN SAMRÆMINGARHÖNNUÐAR	DAGS. ÁRTUNAR

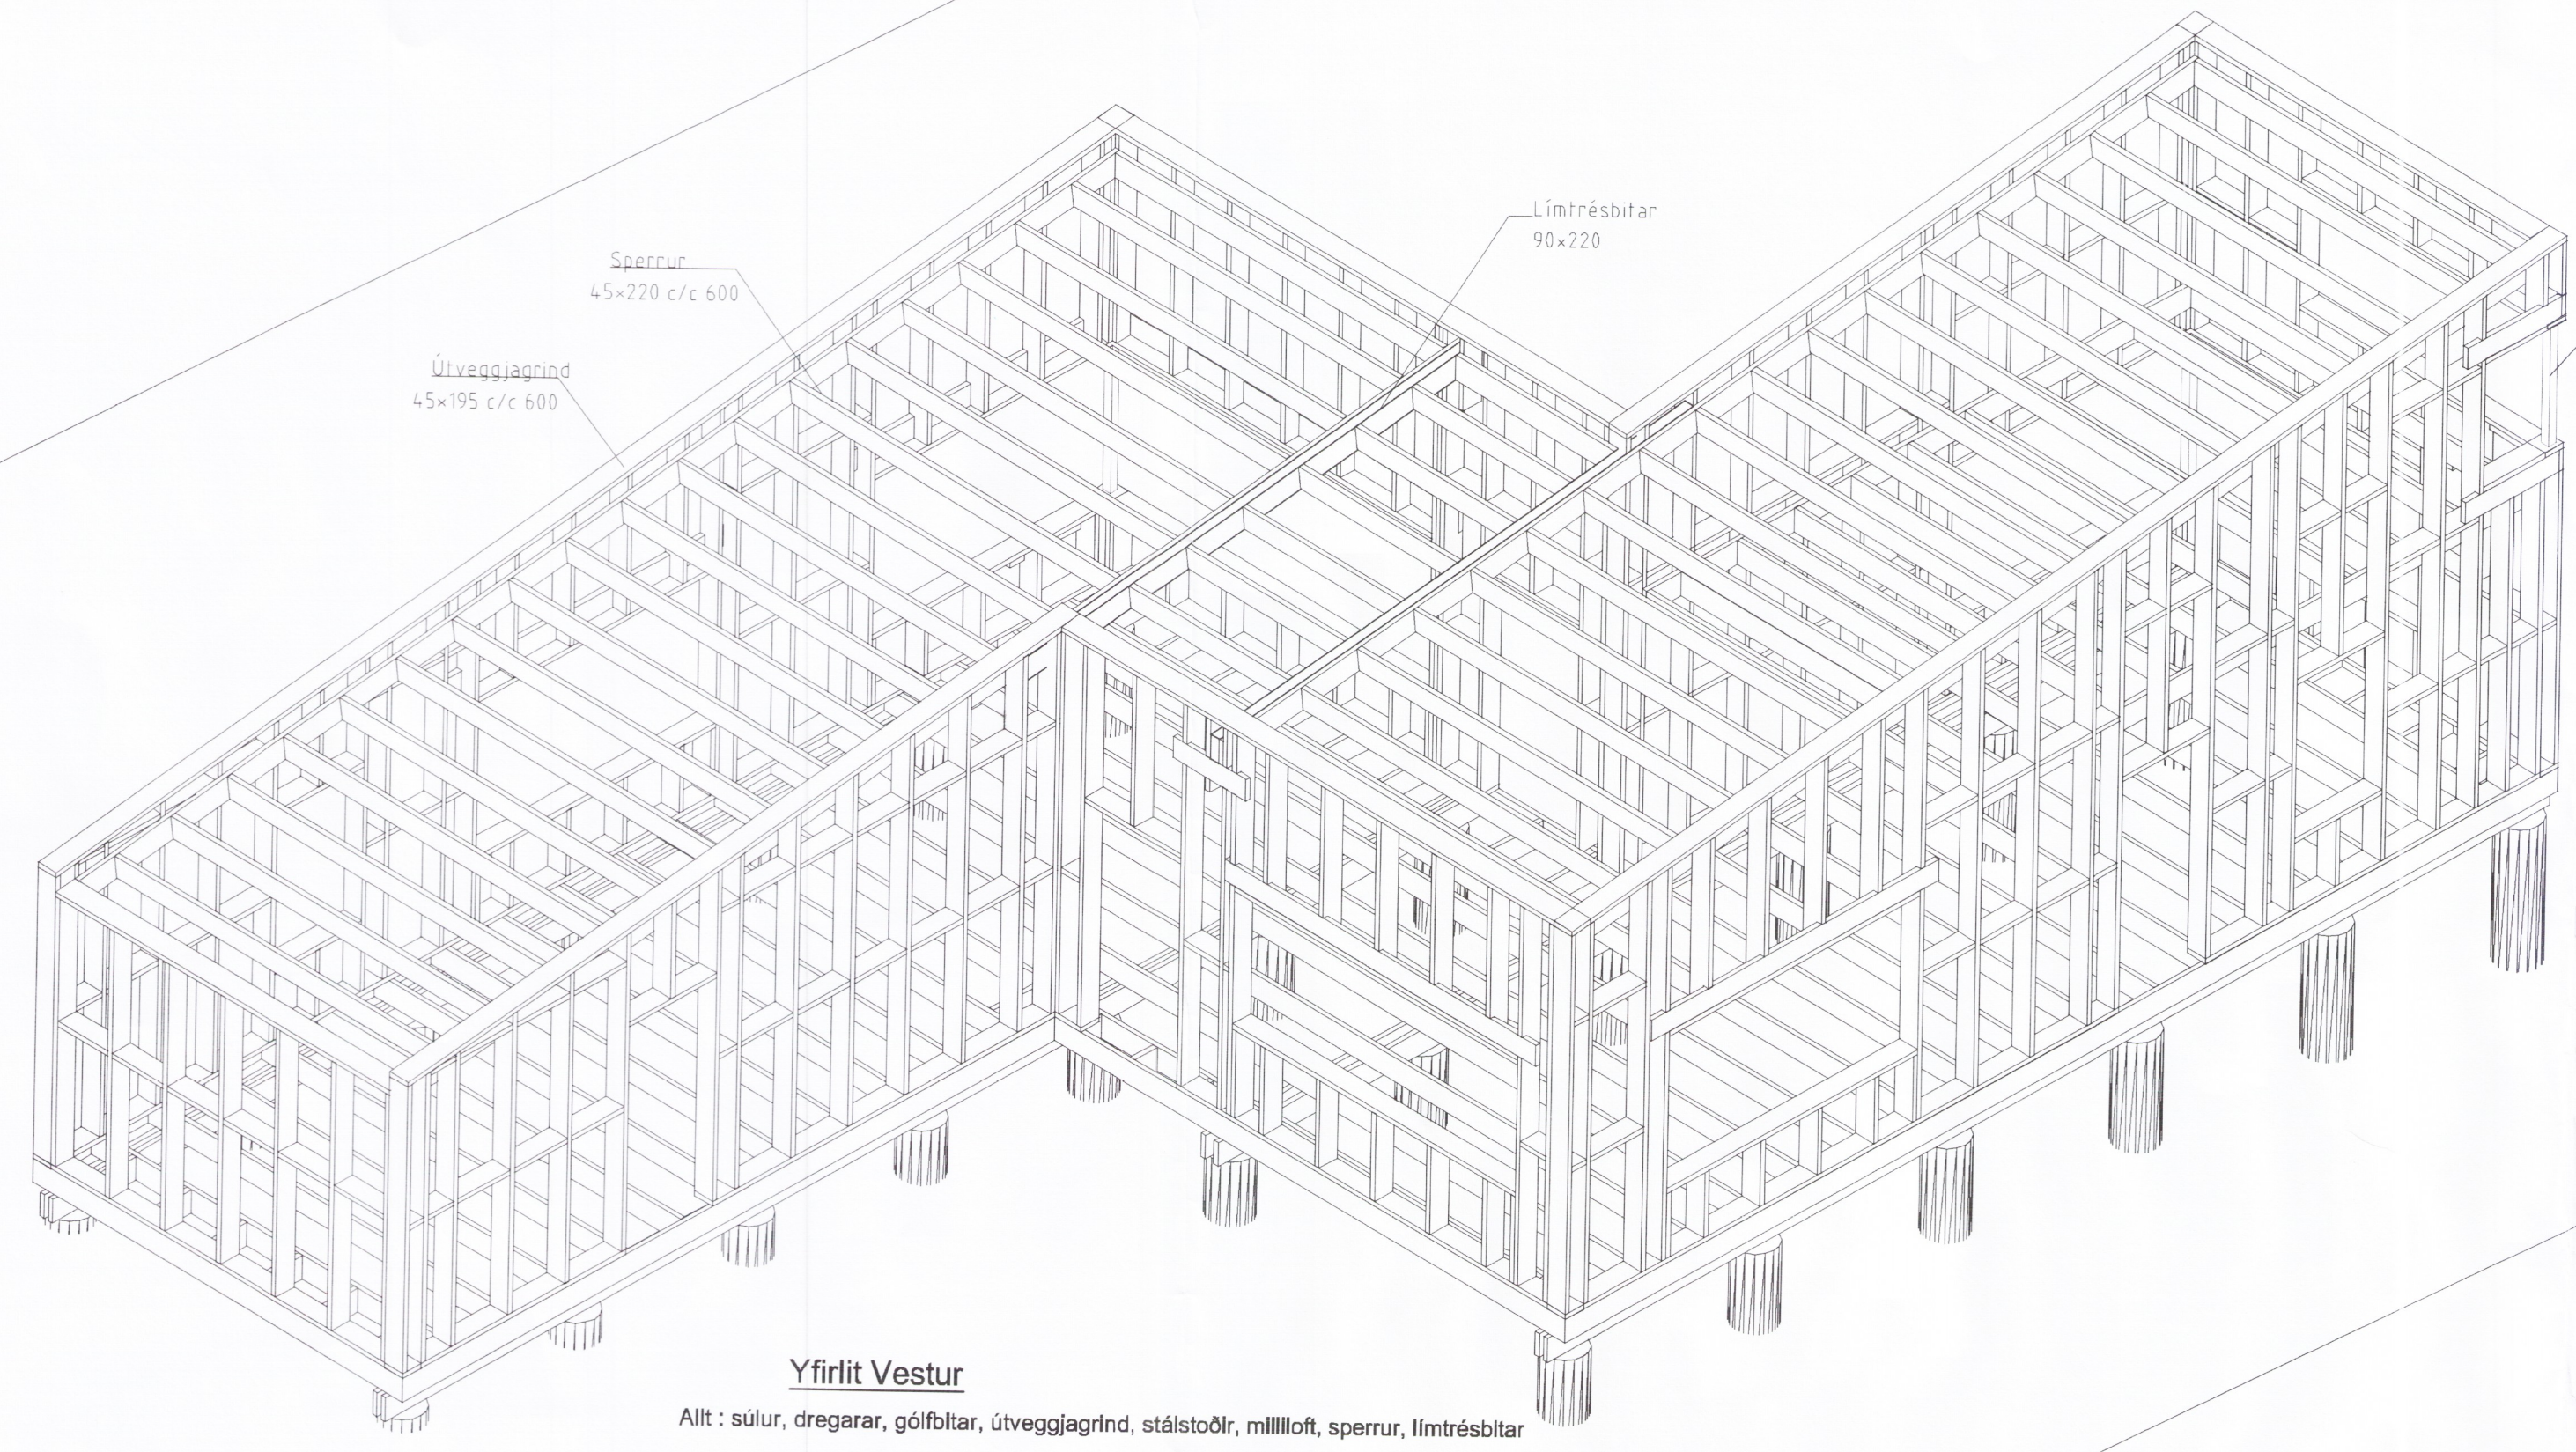
Yfirlit Vestur
 Allt : súlur, dregarar, gólfbitar, útveggjagrind, stálstoðir, milliloft, sperrur, límtresbitar

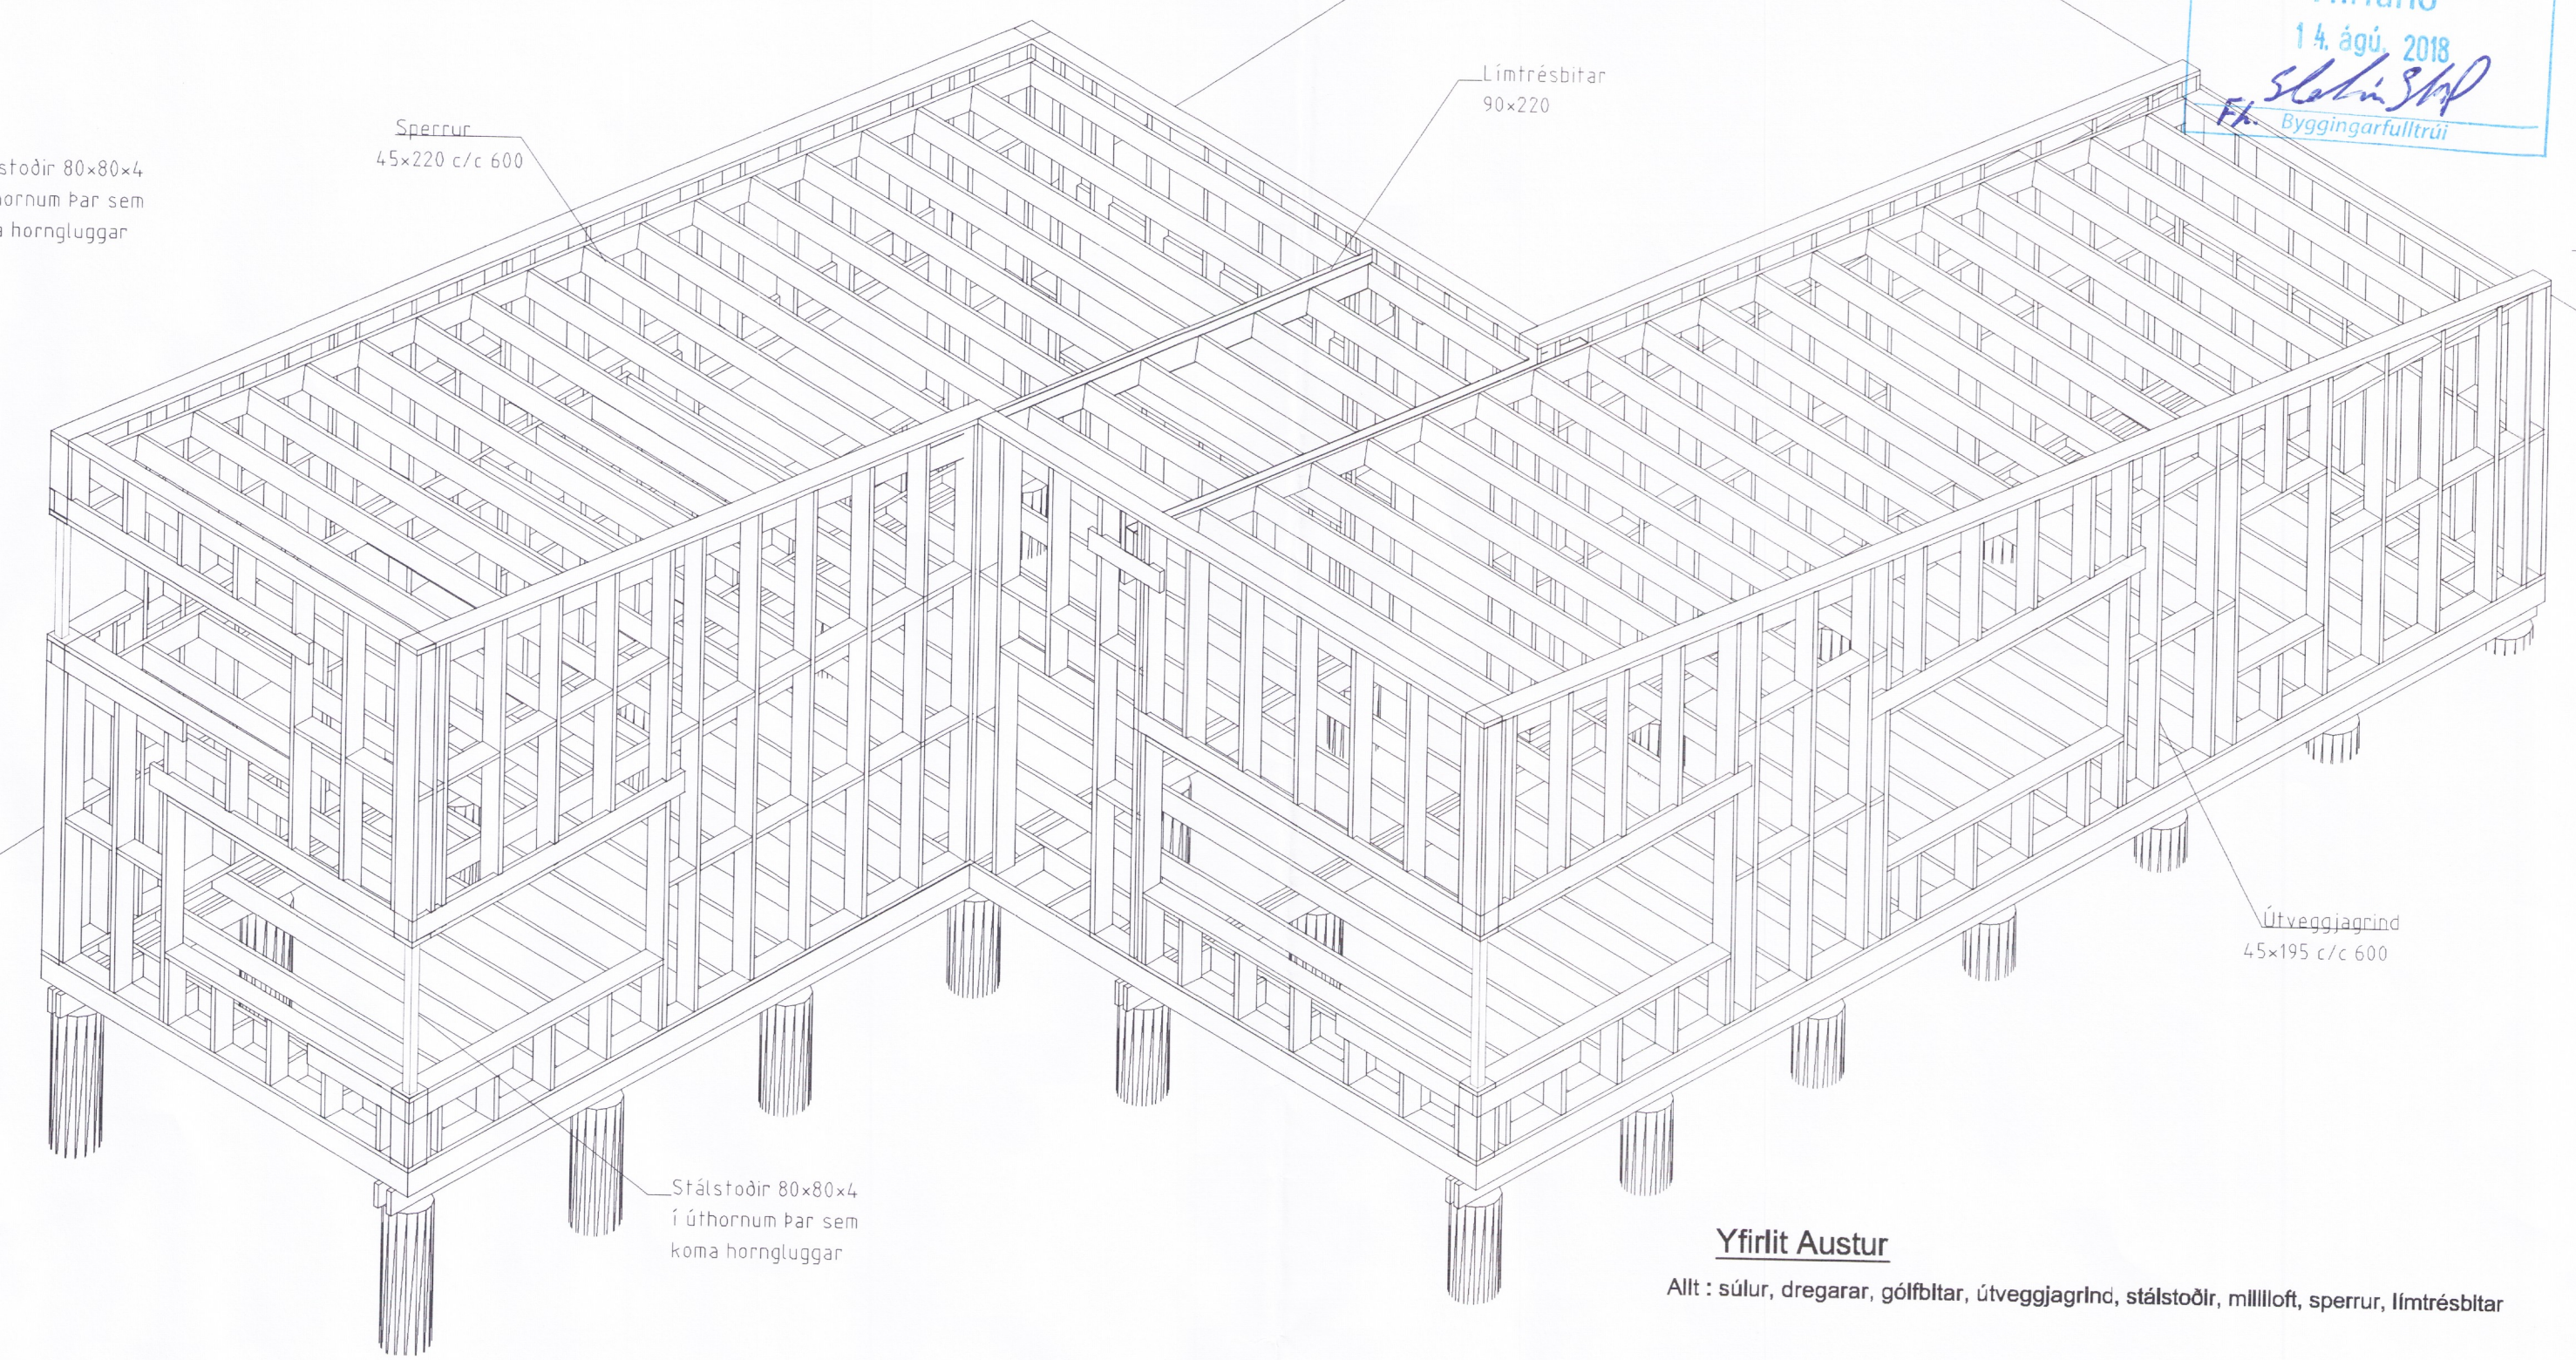
Yfirlit Austur
 Allt : súlur, dregarar, gólfbitar, útveggjagrind, stálstoðir, milliloft, sperrur, límtresbitar

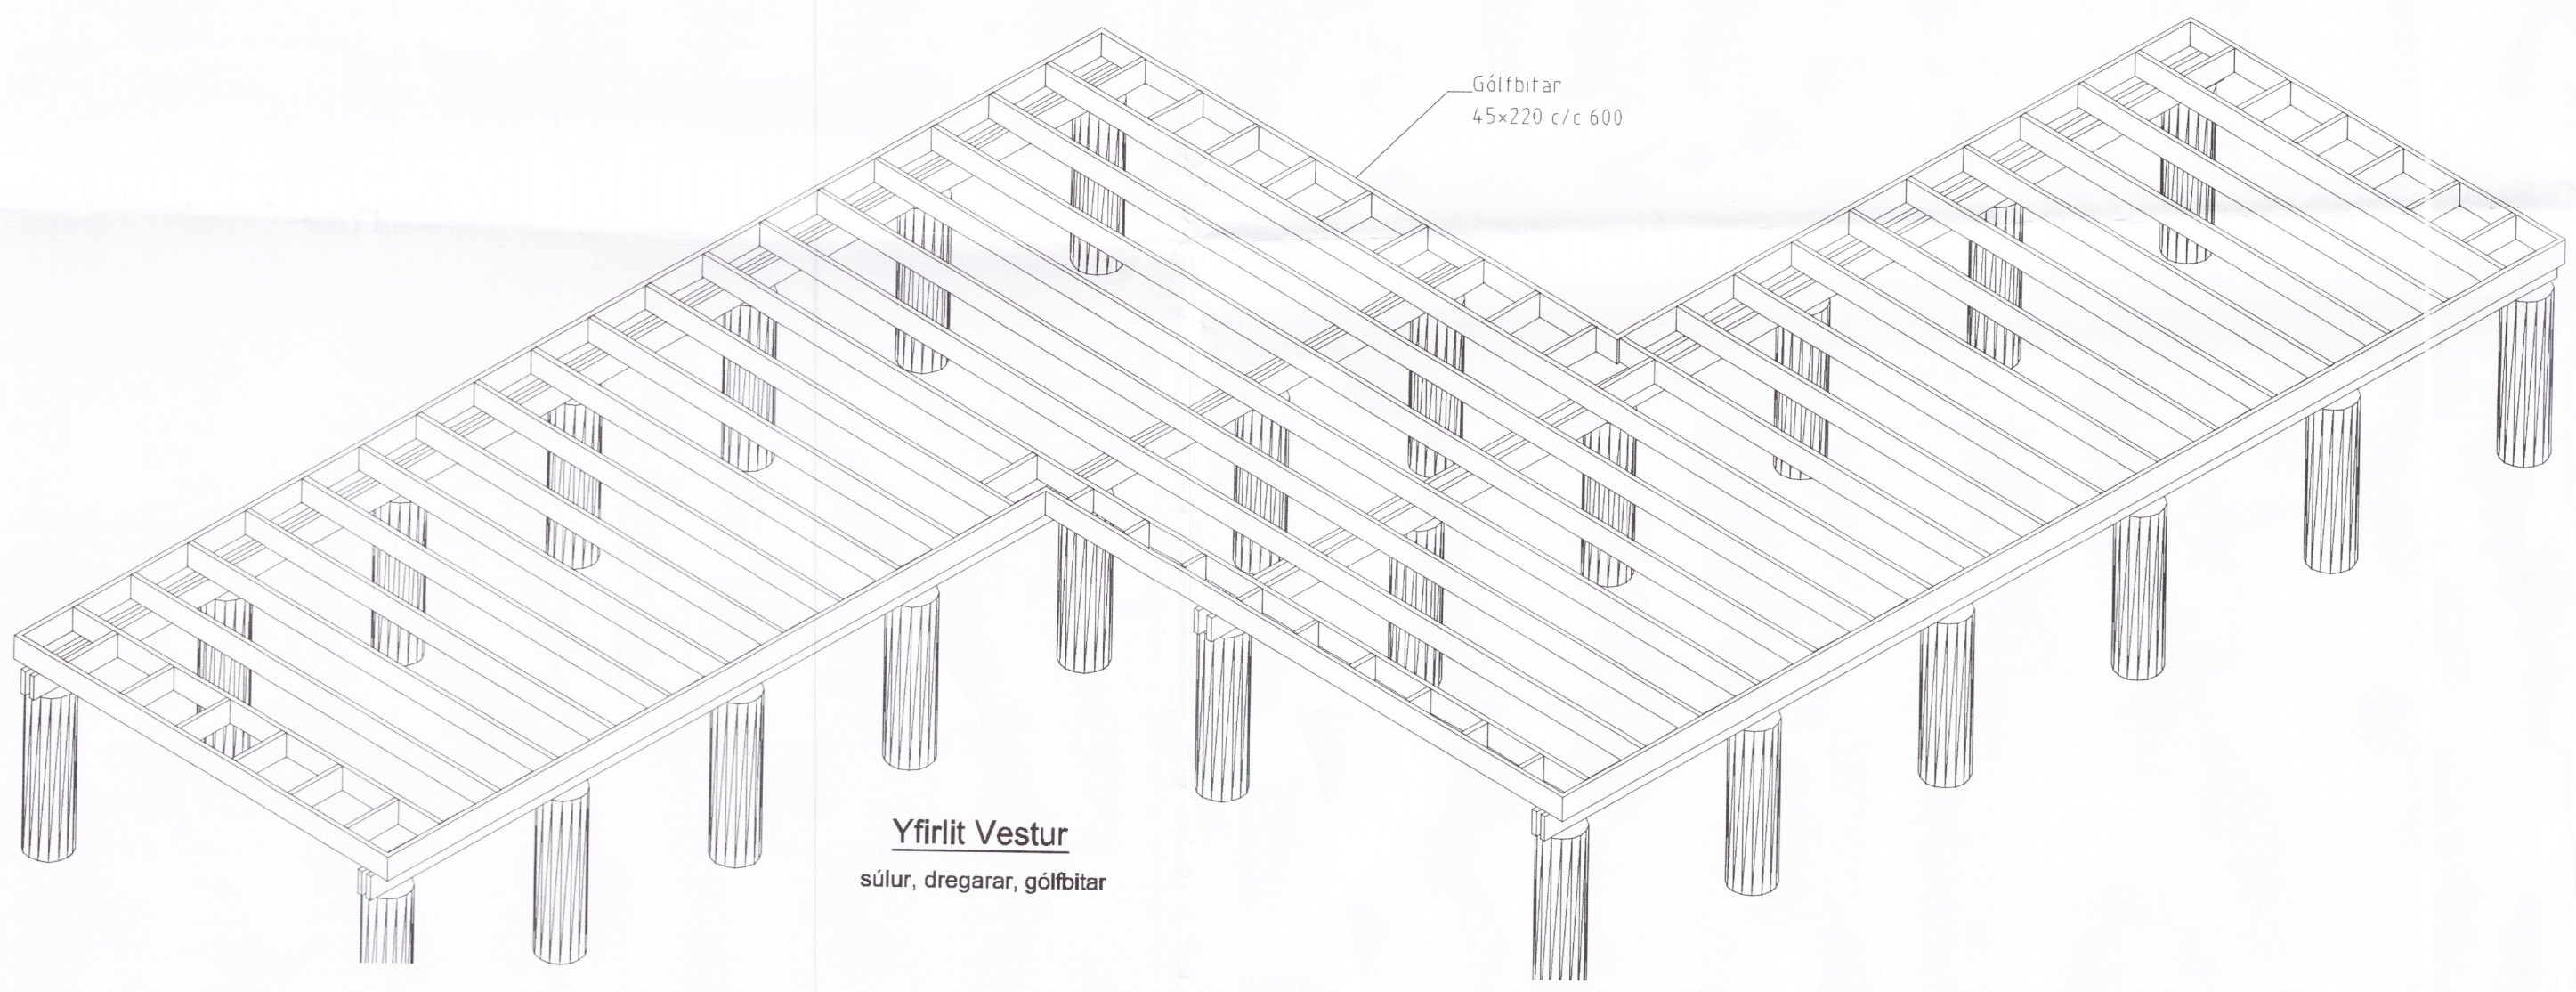
Yfirlit Vestur
 súlur, dregarar, gólfbitar

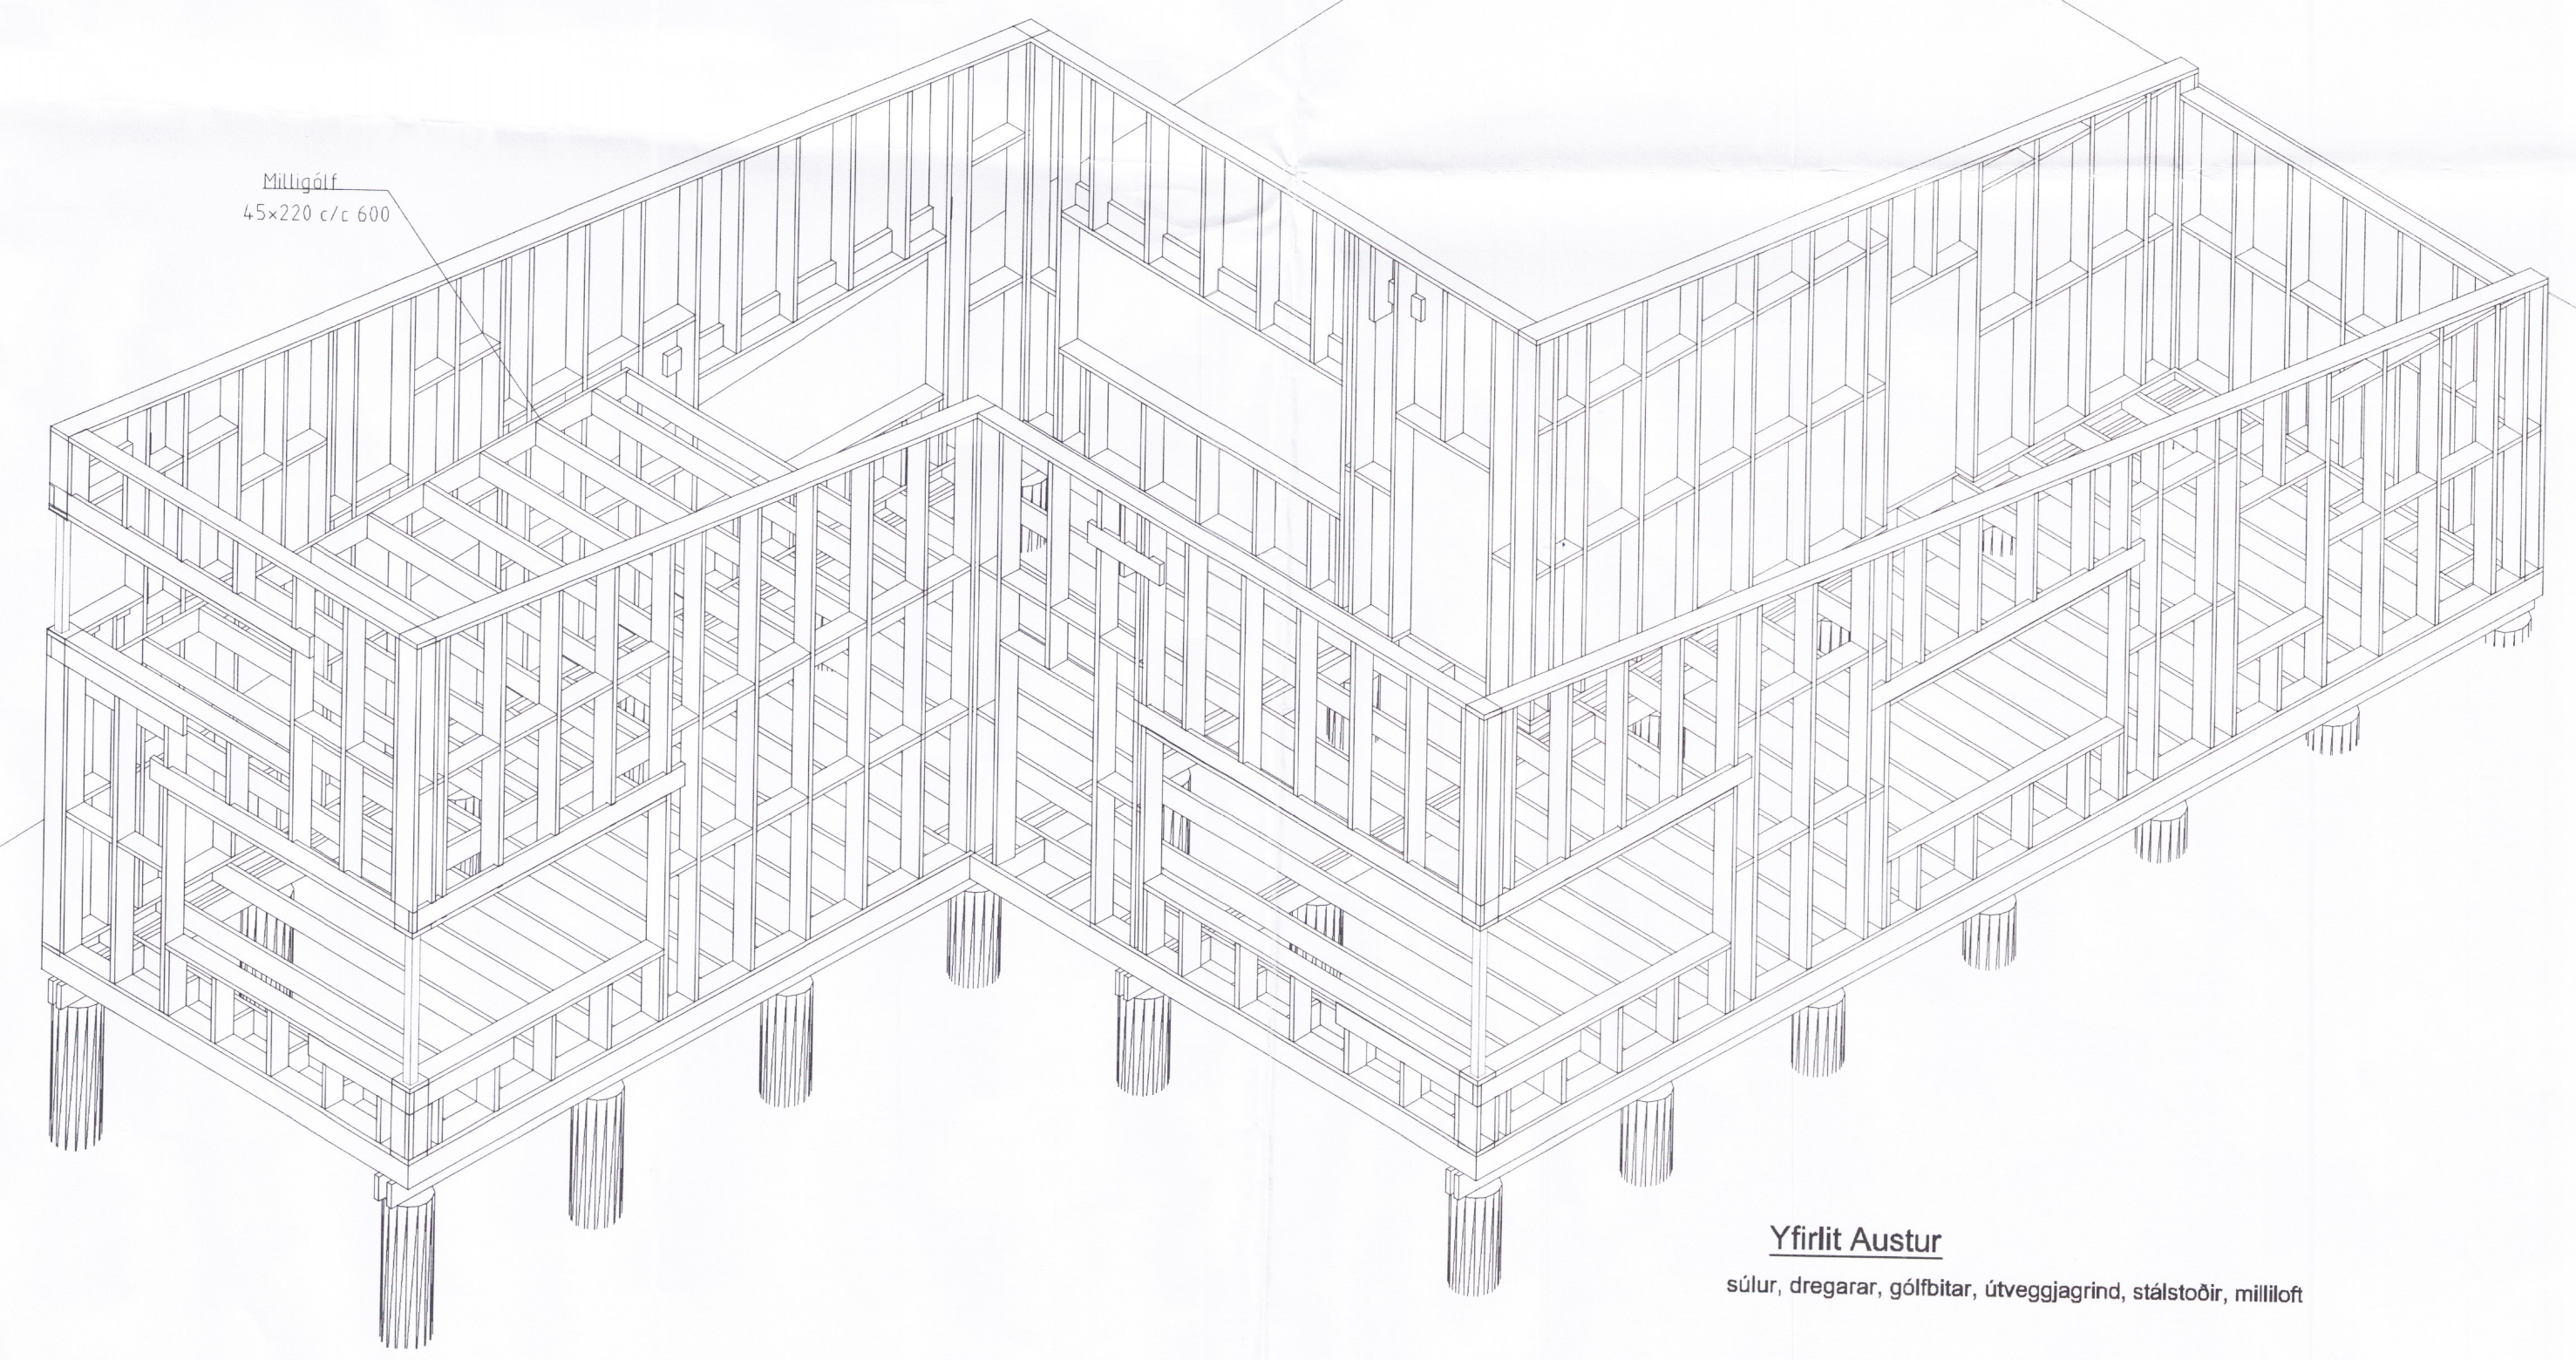
Yfirlit Austur
 súlur, dregarar, gólfbitar, útveggjagrind, stálstoðir, milliloft

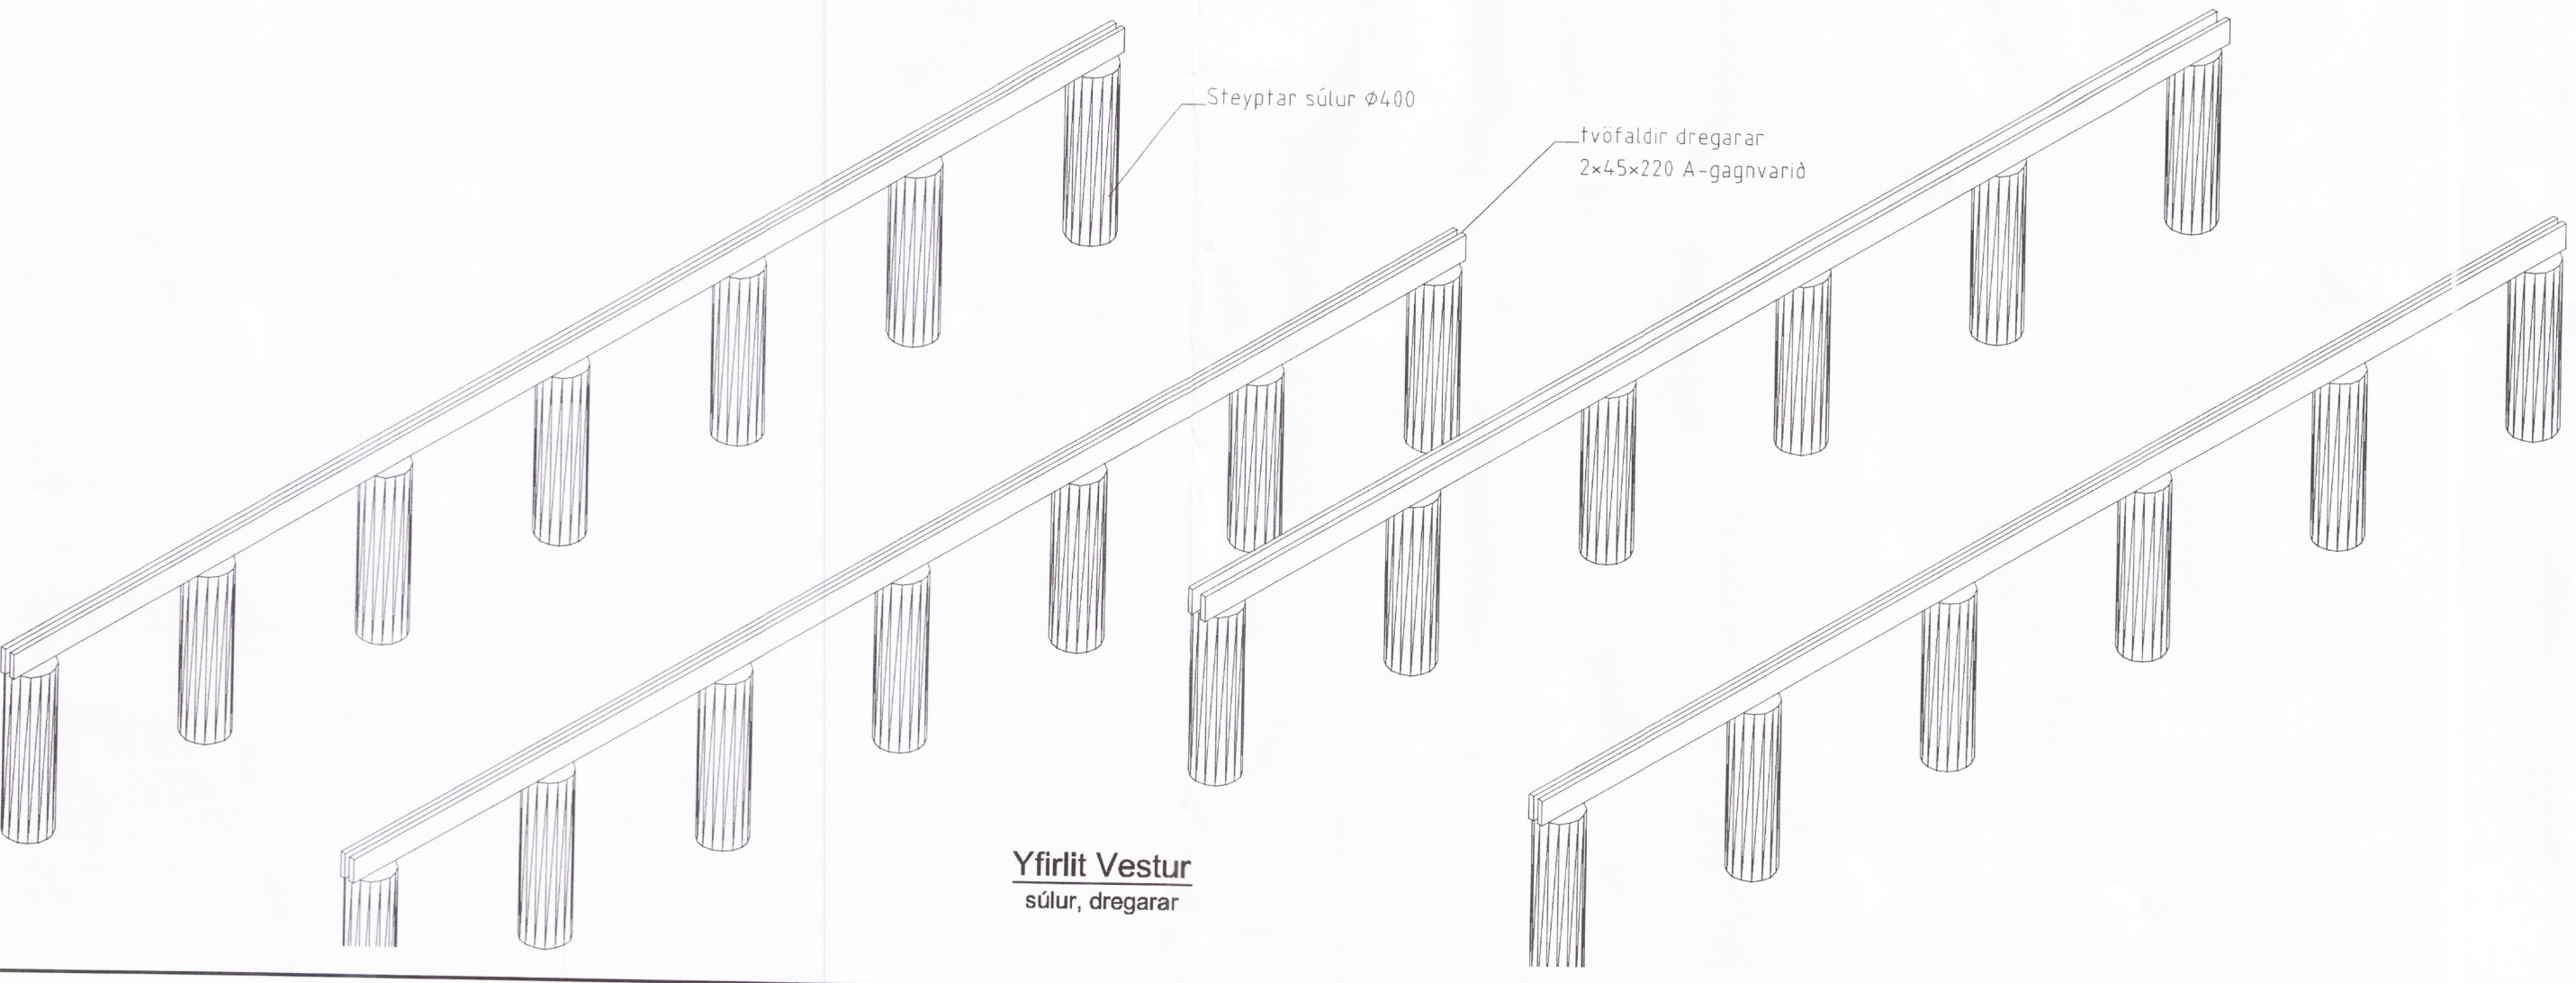
Yfirlit Vestur
 súlur, dregarar
