Stekkatún 1, Bláskógabyggð	Blaðst A2
Landnr 194642, Matshl 3	7
Rafmagn, sökkjar, inntak og einlínunmynd	Dagsetn: júlí 2016
	Mælikvarði: 1 : 50

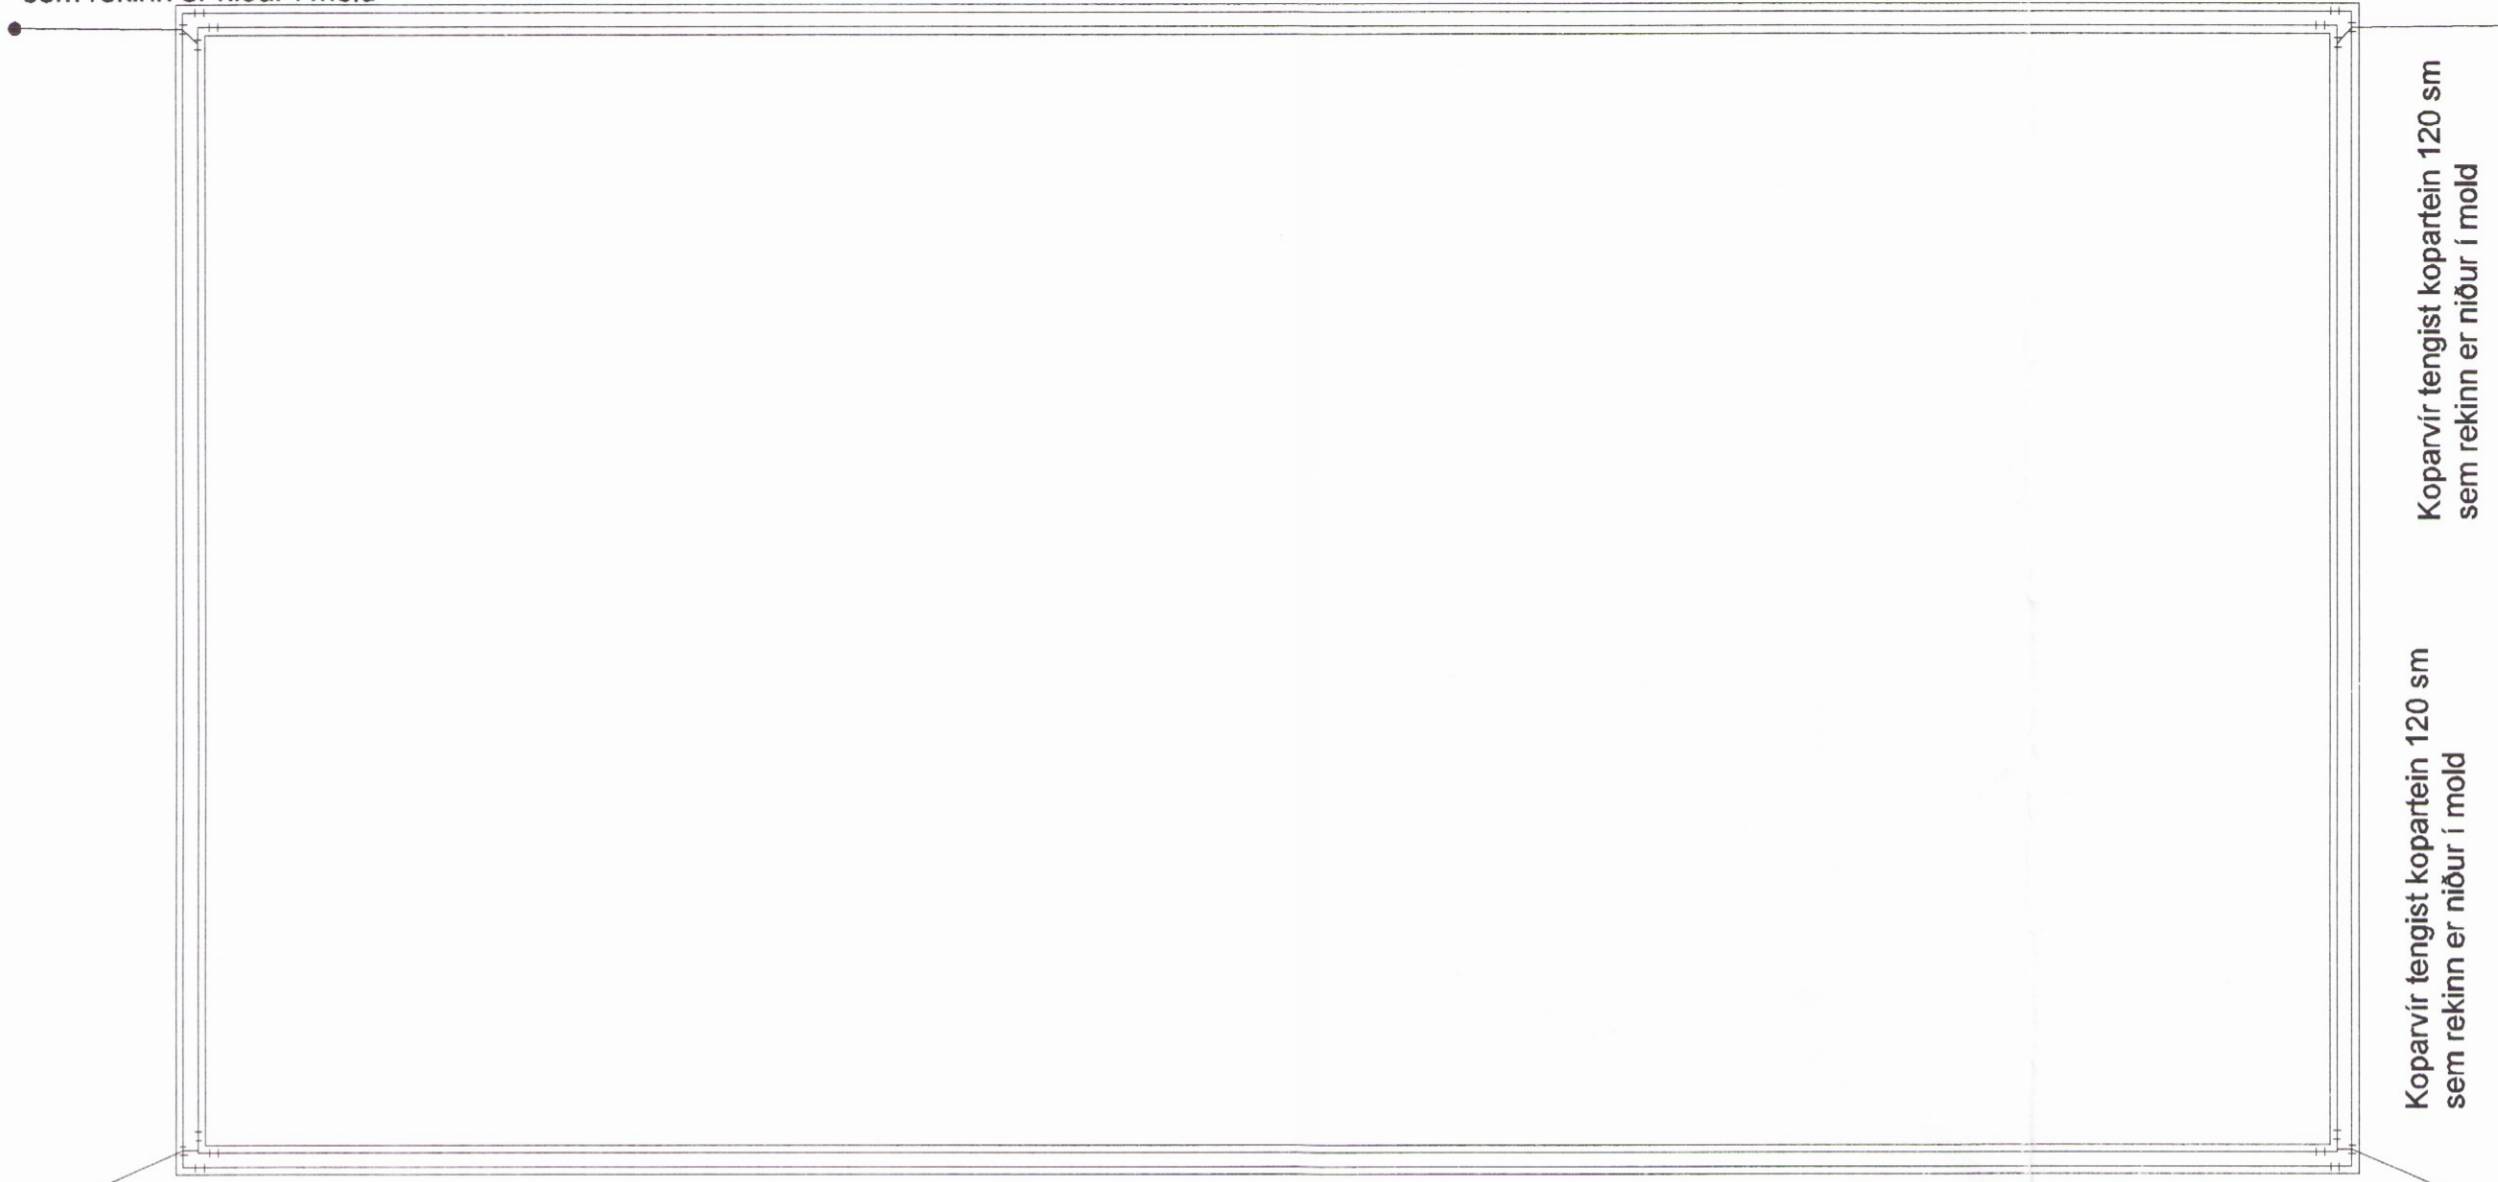
Grunnmynd sökkulvegga 1 : 50

Koparvír tengist kopartein 120 sm sem rekinn er niður í mold

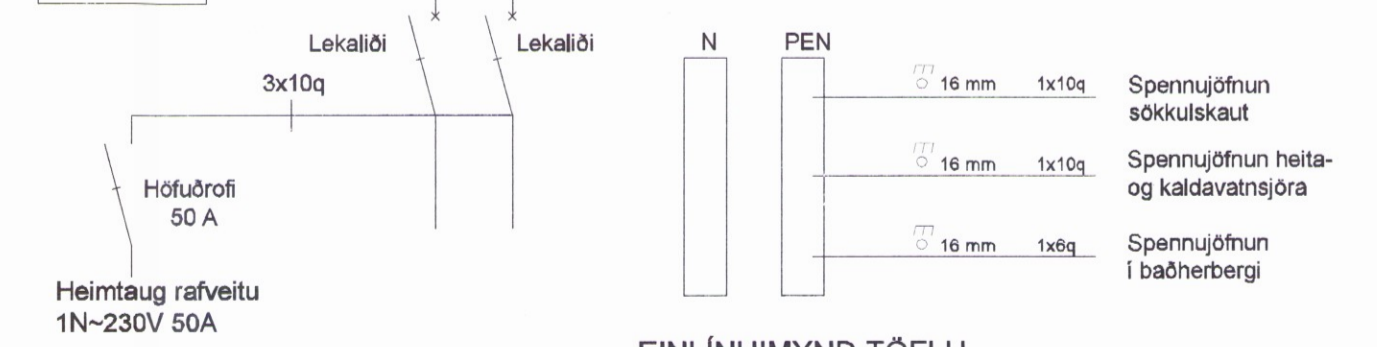
EINLÍNUMYND TÓFLU

gr. 1	16 A	3x4q	20 mm	Eldavél / helluborð
gr. 2	16 A	3x2.5q	16 mm	Ofn
gr. 3	16 A	3x2.5q	16 mm	Uppþvottavél
gr. 4	16 A	3x2.5q	16 mm	Órbylgjuofn
gr. 5	16 A	3x2.5q	16 mm	Þvottavél
gr. 6	16 A	3x2.5q	16 mm	Purkari
gr. 7	10 A	3x1.5q	16 mm	Eldhús/stofa
gr. 8	10 A	3x1.5q	16 mm	Herbergi/gangur
gr. 9	10 A	3x1.5q	16 mm	Bað/þvottur
gr. 10	10 A		16 mm	Laust
gr. 11	10 A		16 mm	Laust
gr. 12	10 A		16 mm	Laust
gr. 13	10 A	3x1.5q	16 mm	Útljós
gr. 14	10 A	3x1.5q	16 mm	Útljós
gr. 15	16 A	3x2.5q	20 mm	Pottur
gr. 16	16 A	3x2.5q	16 mm	Útitengill
gr. 17	10 A	3x1.5q	16 mm	Dæla - gólfhiti
gr. 18	10 A		16 mm	Laust
gr. 19	10 A		16 mm	Laust
gr. 20	10 A		16 mm	Laust
gr. 21	16 A		16 mm	Laust
gr. 22	16 A		16 mm	Laust
