SÖKKULSKAUT  
MKV1:50

Br.	Dags.	Breyting	Br.	Sp.	
Áshildarvegur 23, Kiljuhrauni					
RAFLAGNIR SÖKKULSKAUT					
<b>LJÓSTÆKNI RAFLAGNAHÖNNUN</b>					
Mogúla Sigurðsson rafmagnstæknihönnun, lög. raftegnahönnunur Sólfrúni 28, 105 Reykjavík, kt. 011241 7519 Sími: 552 9559, GSM: 896 0559, vefbætur: mgs@r.is					
Hönnuð:	MS	Teknið:	MS	Yfirleitt:	MS
Sambýkt af:	<i>M. Sigurðsson</i>		Kt.:	011241 7519	
Tölvunúmer:	LT2009/ÁSHILDARVEGUR 23/RAF-ÁSHILDARVEGUR 23				
Mkv.:	1:50		Blaðstærð:	A1	
Dags:	18-03-2008	Nr.:	LT1148	6 af 6

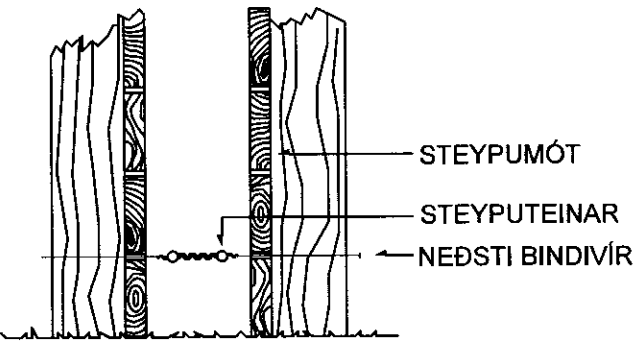
SNIB Í STEYPUMÓT

TVEIR NEDSTU STEYPUVEINAR BINDAST SAMAN MED STEYPUVEINUM OG VÍRAKLEMMUM

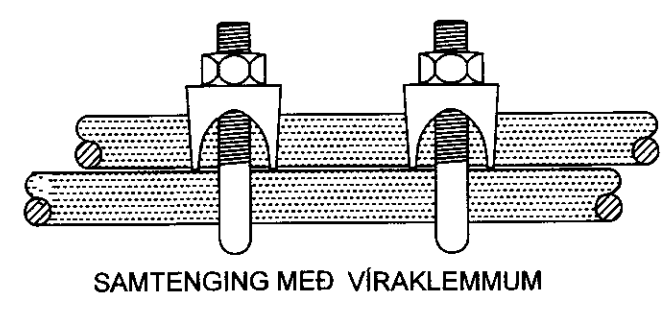
SÖKKULSKAUT  
Dæmigerður frágangur

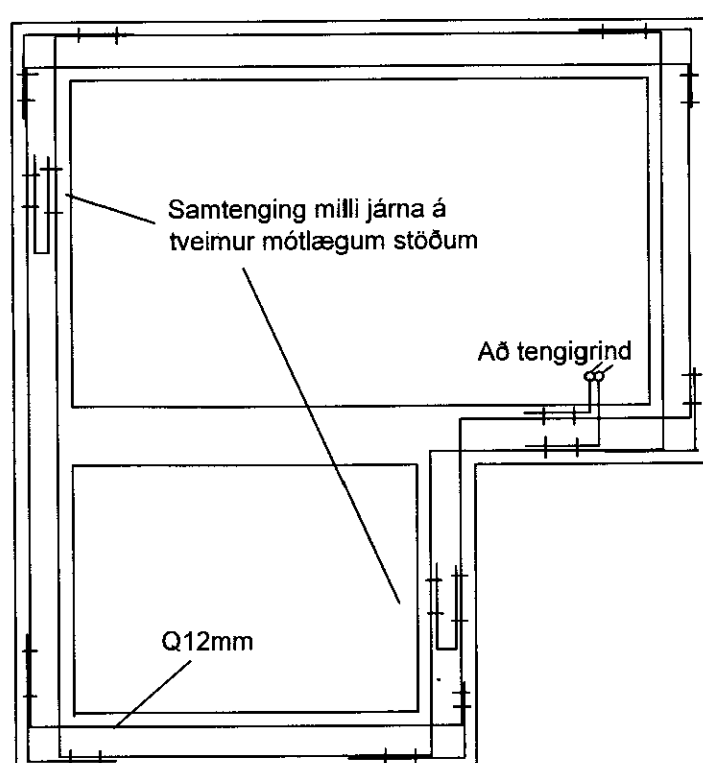
Grunnmynd sökkulveggja

SÖKKULSKAUT UPP Í TENGIKASSA SJÁ SJÁ SNEIDINGU A-A
